Durable restorations are value for money

Nadeem Younis describes how he repaired the fractured ceramic of a porcelain-fused-to-metal bridge with Venus Pearl composite

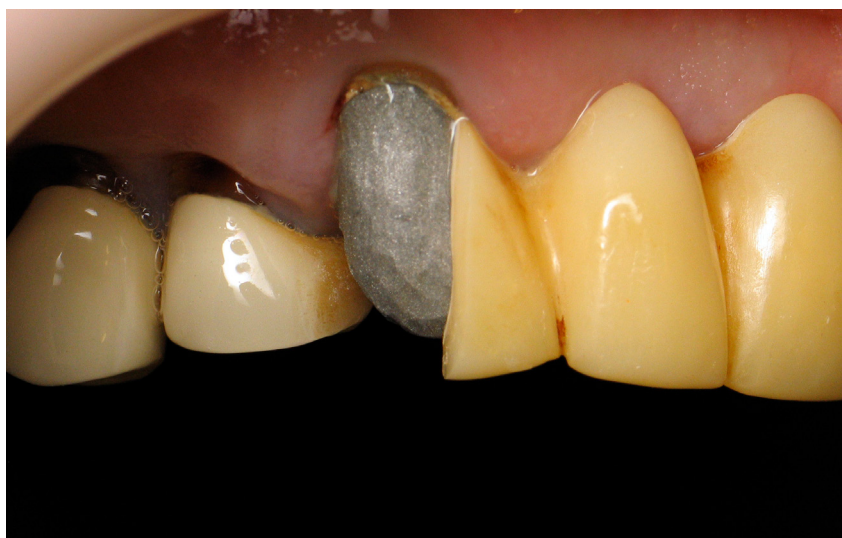
Figure 1: The fracture was to the porcelain on the upper right canine abutment

A middle aged female patient presented to Bridge Dental Practice with fractured ceramic on a porcelain-fused-to-metal (PFM) three-unit bridge. On examination, the fracture was to the porcelain on the upper right canine abutment (Figure 1). Apart from the porcelain fracture, the abutments were undamaged.

There are a number of reasons why the porcelain on a PFM bridge might fracture. Damage can result from a poor bond of the ceramic to the underlying metal substructure. Durability can also be affected by the development of micro-cracks in the ceramic during fabrication of the bridge in the laboratory.

An underlying occlusal parafunction, not identified during the planning and preparation stages, or during the fitting of the restoration, might also result in a fracture.

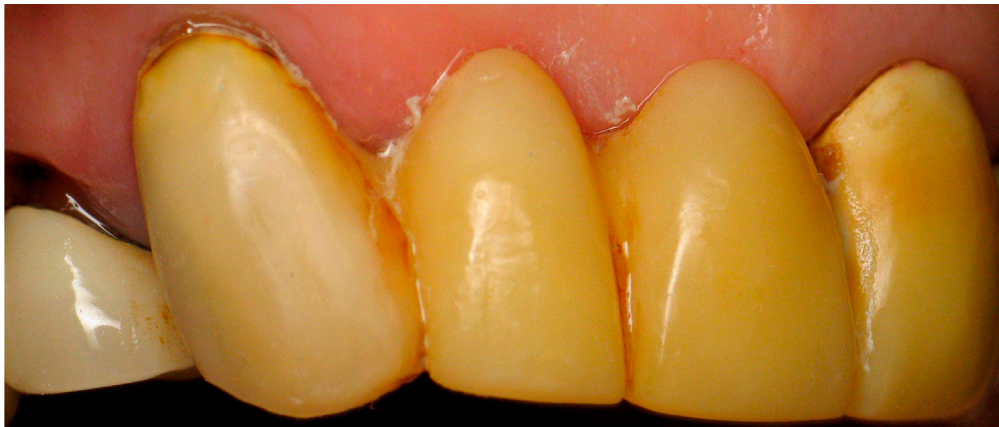
Figure 6: The composite provided an economical repair to the fractured bridgework and remains fully intact after four years

The patient was very happy with the final result. The composite provided an economical repair to the fractured bridgework and remains fully intact after four years (Figure 6). **D**
