Minimally invasive, economical restoration

Nadeem Younis describes a case where he repaired damaged central incisors with direct composite resin and tints

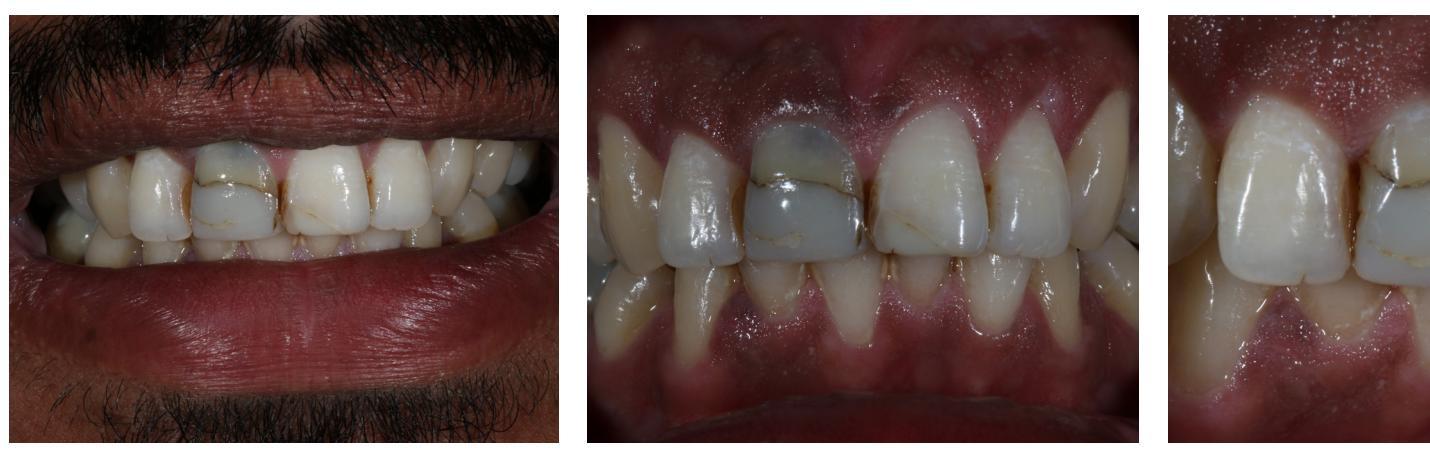
Figure 1: The patient was unhappy with the appearance of his upper central incisors

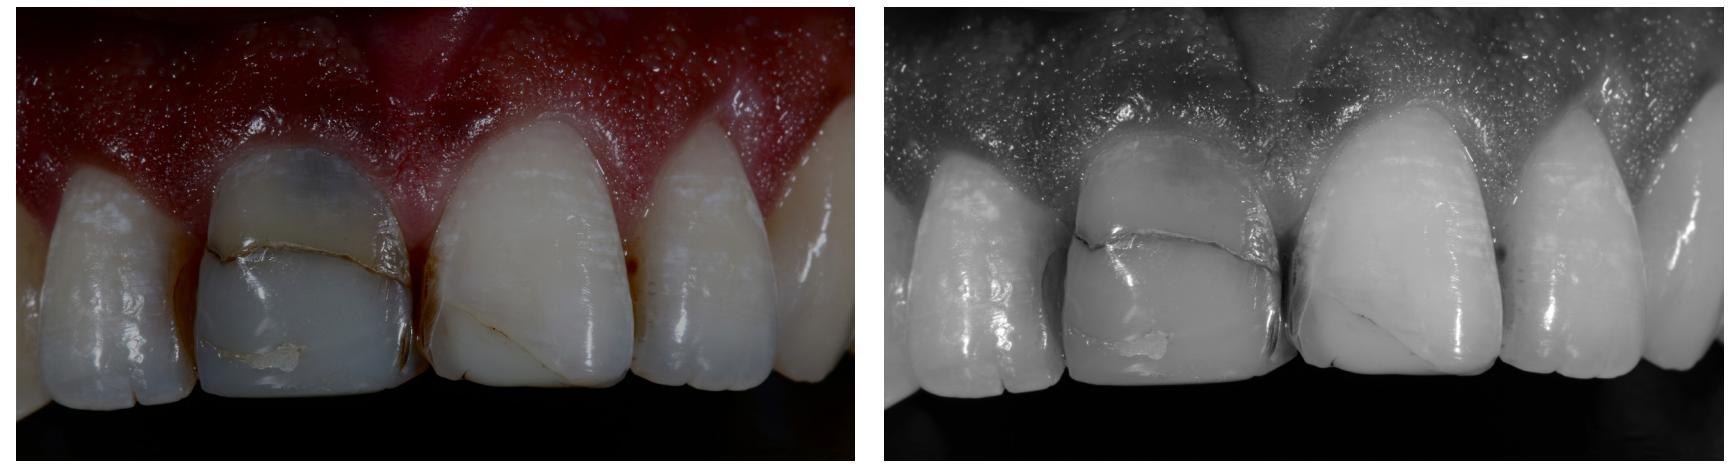
Figures 2 and 3: The current composite restorations were opaque with poor tooth morphology

Figures 4 and 5: The upper left central incisor also had a broad white banding effect, caused by fluorosis

poor tooth morphology (Figures 2 and 3).

It was explained that further root canal treatment and tooth whitening would need to take place before composite restoration. The upper centrals were of a different value, so it would be quite a challenging case to treat with direct composite resin. The upper left central incisor also had a broad white banding effect, caused by fluorosis, which would need to be reproduced in order to match the existing teeth (Figures 4 and 5).

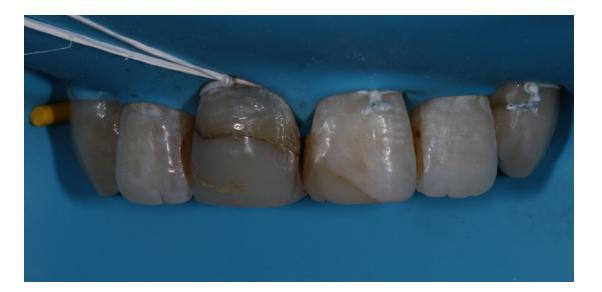
Figure 6: The teeth were isolated using rubber dam and floss ties

The teeth were isolated using rubber dam and floss ties (Figure 6). Root canal treatment on the upper right central incisor was carried out over two visits (Figure 7). The canal was obturated following confirmation of the resolution of the periapical radiolucency.

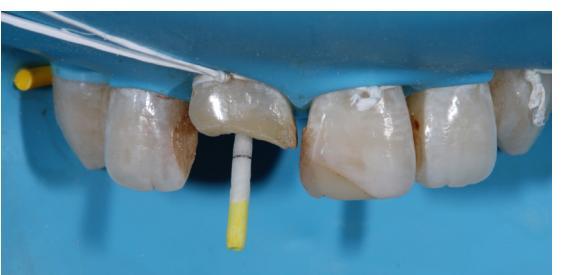
Figure 7: Root canal treatment was carried out over two visits

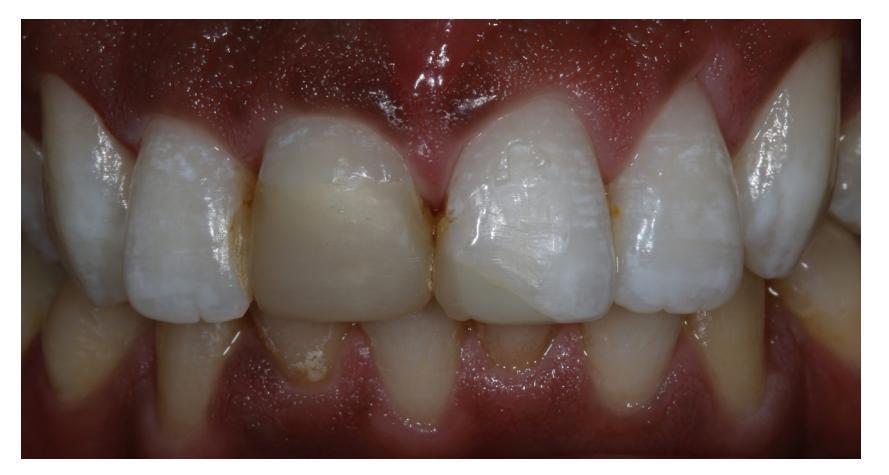
Figure 8: Kulzer Venus Pearl A1 shade was used to restore the tooth to full contour

Kulzer Venus Pearl A1 shade was used to restore the tooth to full contour (Figure 8). The final restoration would also be completed with Venus Pearl composite; therefore, uniformity of materials would be required. The composite is easy to use and produces highly aesthetic results.

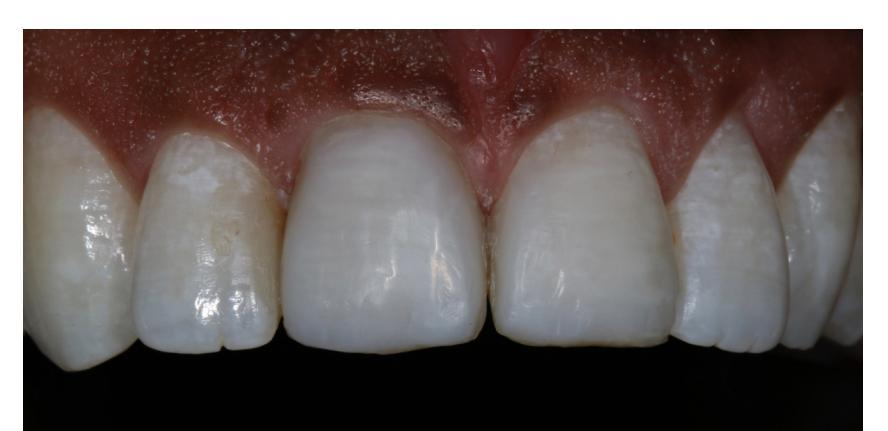
Figure 10: The teeth were restored incrementally with Kulzer Venus Pearl Opaque Light Chromatic and B1 shade

The teeth were restored incrementally with Kulzer Venus Pearl Opaque Light Chromatic (OLC) and B1

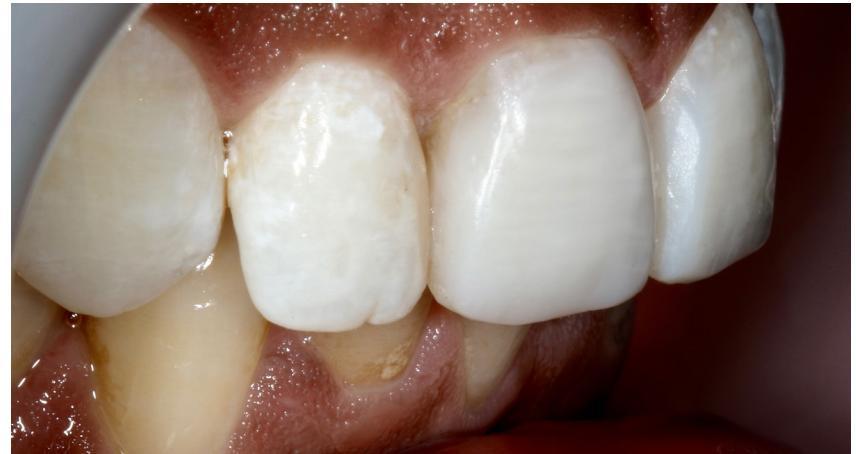
Figure 12: A glossy finish was achieved with the Kulzer Venus Supra polishing kit, and Sof-Lex discs

Venus Color White Tints were used in order to modify the value of the restorations and reproduce the white broad lines of fluorosis on the upper central incisors (Figure 11). A final layer of Kulzer Durafill VS was placed on the labial surface. Durafill is a light-curing microfiller composite for aesthetic anterior restoration. It has excellent shade match and lustre. A glossy finish was achieved with minimal effort using a simple twostep regime with the Kulzer Venus Supra polishing kit, and Sof-Lex discs (Figure 12).

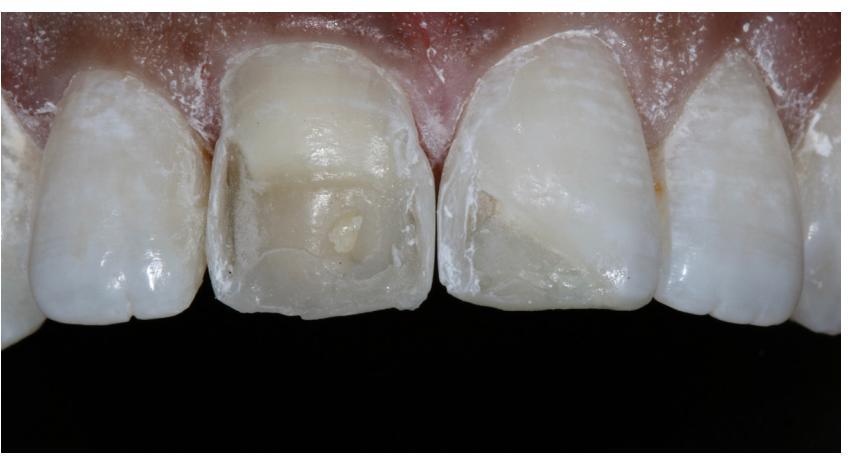
Figure 9: The temporary composite restorations were reduced to the palatal shell

Three weeks of night-time tooth whitening commenced, using Boutique Whitening 16% carbamide peroxide gel, until the desired shade was achieved. A three-week break post tooth whitening was advised, to allow the oxygen to dissipate from the enamel and dentine, which would otherwise interfere with the bonding and composite build-up. The temporary composite restorations were reduced to the palatal shell using a fine tapered bur (Figure 9). A bevel was placed on the labial enamel.

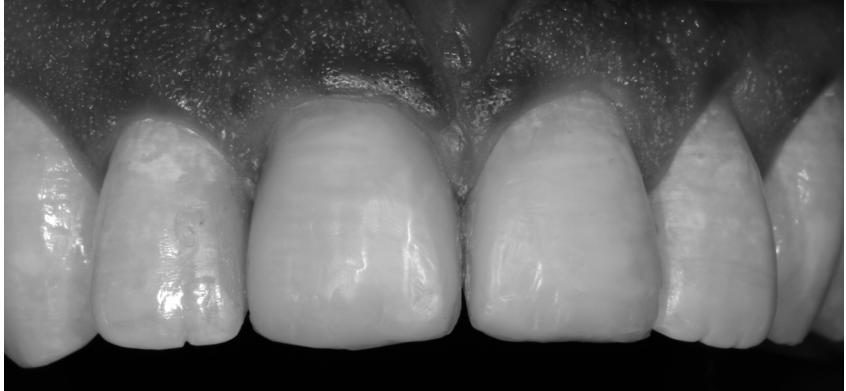
Figure 11: Venus Color White Tints were used in order to modify the value of the restorations and reproduce the white broad line of fluorosis on the upper central incisors

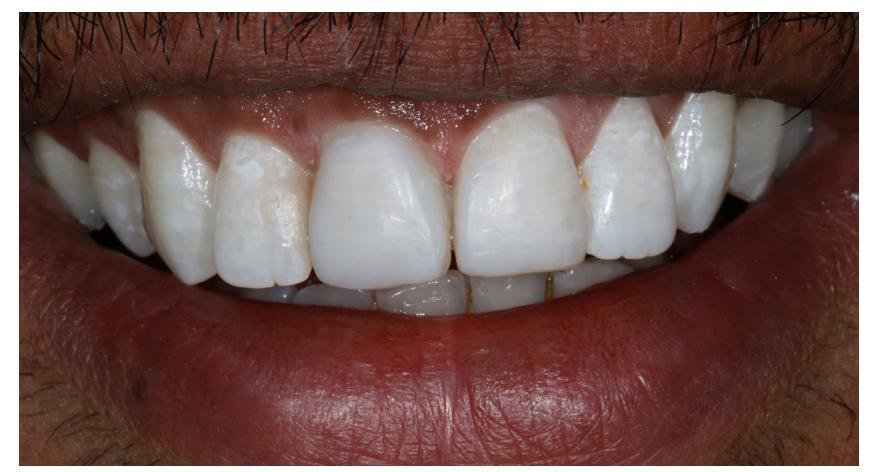
Figure 13: The patient was extremely pleased with the final result

The patient was extremely pleased with the final result (Figure 13). The composite resin provided an aesthetic, minimally-invasive and cost-effective restoration. The appropriate use of Venus Color tints created the finishing touches, to replicate the patient's natural smile. **D**
